Transit Asset Management Plan

Pioneer Valley Transit Authority

Cambridge Systematics, Inc.

September 2018

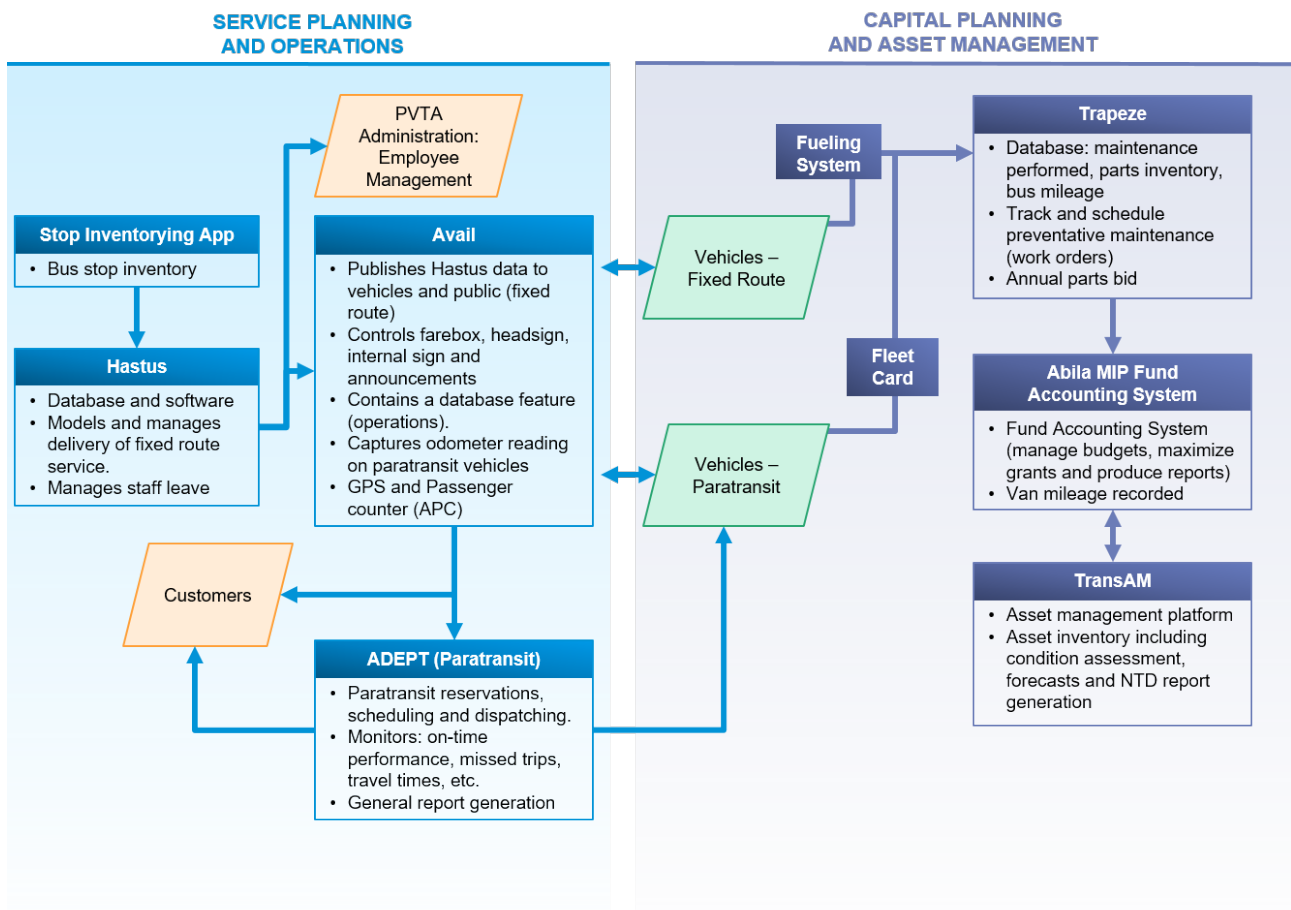
Figure 4.1 Relationship of Key PVTA Systems

A number of other IT systems have been adopted by PVTA to assist in the collection, tracking and analyzing of data related to their capital assets. The relationship and interactions between all of these systems is detailed in Figure 4.1.

To further help manage and inform the decision-making process, PVTA is currently implementing the TransAM Asset Management system as their primary tool for managing all capital assets. The software application captures key information on all assets and their related attributes, including classification, purchase date, purchase price, mileage, condition, maintenance history, ULBs and other policy information.
